TYPES OF ENGINE MIS-ALIGNMENT

**ANTARES 44 SUPPORT
DRIVELINE SERVICE
SP-04-10
SHEET 1 OF 2**

**ANTARES 44 SUPPORT
DRIVELINE SERVICE
SP-04-10
SHEET 2 OF 2**

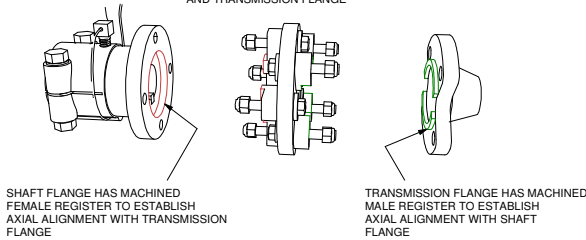
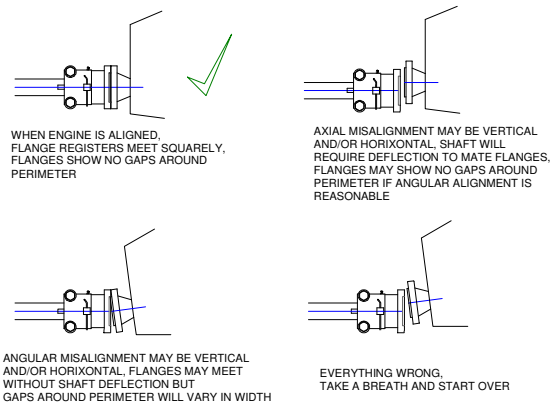
PORT AND STARBOARD DRIVELINES ARE ANGLED OUTBOARD SO SHAFT CAN CLEAR RUDDER/SKEG WHEN REMOVED

ALTHOUGH THE BEARINGS WILL MAINTAIN THE APPARENT SHAFT LINE, ANGULAR ENGINE MISALIGNMENT WILL INDUCE BEND FORCES IN SHAFT, COMPOUNDING STRESSES WITHIN THE SHAFT, GENERATING RUNOUT AND CAUSING VIBRATION, POSSIBLE SEAL LEAKAGE, AND BEARING WEAR

A BENT STRUT (RARE) CAN MISALIGN THE SHAFT BEARINGS

FLEXIBLE COUPLING HAS OPPOSITE REGISTERS ON BOTH FACES TO CORRESPOND WITH SHAFT AND TRANSMISSION FLANGE

ANGULAR MISALIGNMENT IN HORIZONTAL PLANE, USE ENGINE MOUNT SLOTTED BOLT HOLES TO ADJUST ENGINE POSITION TRANSVERSELY, MONITOR AND CORRECT AXIAL DISPLACEMENT CONSEQUENCES

SHAFT LINE IN VESSEL IS FIXED AND NOT ADJUSTABLE, MAKE SURE SHAFT REMAINS APPROXIMATELY CENTRED IN TUBE AT SHAFT SEAL, AXIAL MISALIGNMENT WILL DIRECTLY AFFECT THIS PARAMETER. CHECK WITH SEAL IN PLACE BY CENTERING SHAFT WITHIN ITS FREEPLAY IN BOTH PLANES WITH FLANGE DISCONNECTED

AXIAL MISALIGNMENT IN HORIZONTAL PLANE, USE ENGINE MOUNT SLOTTED BOLT HOLES TO ADJUST ENGINE POSITION TRANSVERSELY, MONITOR AND CORRECT ANGULAR DISPLACEMENT CONSEQUENCES

NOTE:
CORRECT SHAFT POSITION IS PERMANENTLY ESTABLISHED BY STRUT AND INTERMEDIATE TUBE BEARINGS, THE ENGINE POSITION IS ADJUSTED TO ACHIEVE ALIGNMENT

ANGULAR MISALIGNMENT IN VERTICAL PLANE, USE ENGINE MOUNT ELEVATION BOLTS TO ADJUST ENGINE POSITION VERTICALLY, MONITOR AND CORRECT AXIAL DISPLACEMENT CONSEQUENCES

AXIAL MISALIGNMENT IN VERTICAL PLANE, USE ENGINE MOUNT ELEVATION BOLTS TO ADJUST ENGINE POSITION VERTICALLY, MONITOR AND CORRECT ANGULAR DISPLACEMENT CONSEQUENCES

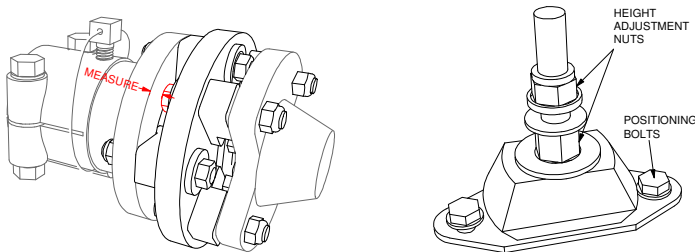
A FLEXIBLE COUPLING WILL TOLERATE SOME MINOR ANGULAR MISALIGNMENT, R&D MODEL ILLUSTRATED WILL ACCEPT A .010" DIFFERENCE IN THE CLEARANCE BETWEEN THE RED PAINTED BOLT HEAD AND FLANGE FACE, MEASURED IN FOUR POSITIONS AS THE COUPLING IS ROTATED. THIS CAN BE MEASURED WITHOUT DISCONNECTING THE FLANGES. SEE ALSO THE R&D LITERATURE.

ENGINE MOUNT POSITIONING BOLTS AND HEIGHT ADJUSTMENT NUTS MAY WORK LOOSE RESULTING IN MISALIGNMENT. CHECK ALL DRIVELINE FASTENERS FOR TIGHTNESS AT REGULAR INTERVALS.

FOR SMOOTHEST RUNNING EVERY ATTEMPT SHOULD BE MADE TO ACHIEVE THE MOST ACCURATE ALIGNMENT REGARDLESS OF THE COUPLING TOLERANCE.

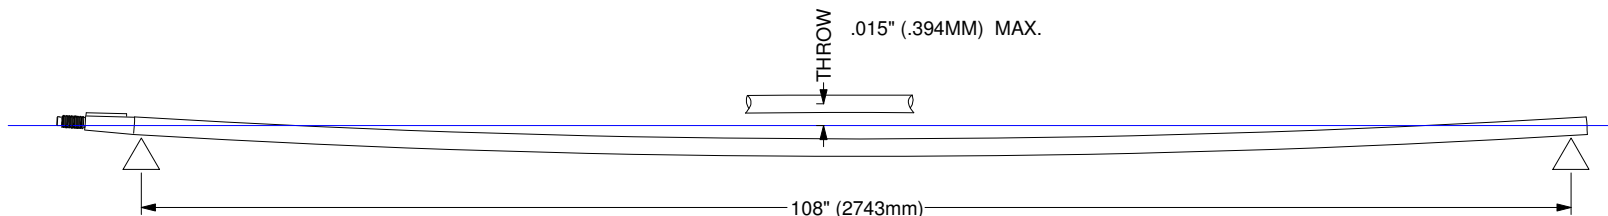
NEW SHAFT RUNOUT TOLERANCE PER ABYC STANDARD,
(USUALLY .005" (.127MM) OR BETTER BY SHAFT MANUFACTURER'S STANDARD)

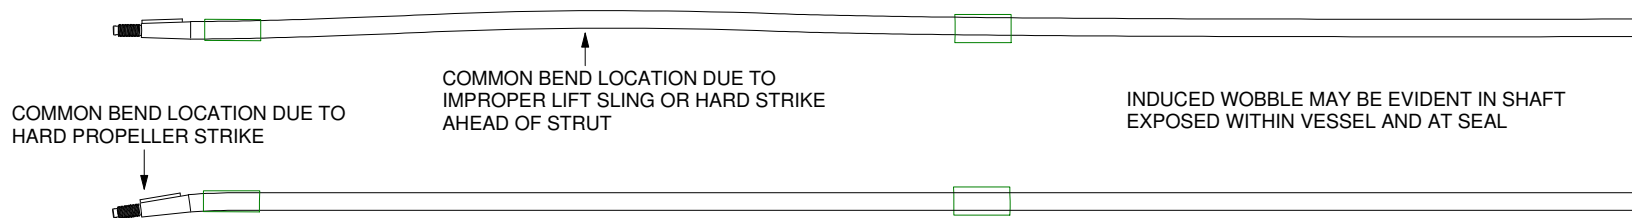
IF THEY GET BENT

NOTE:
RUNOUT DUE TO A BENT SHAFT OR DAMAGED COUPLING
IS READILY APPARENT WHEN ROTATED BY HAND,
MIS-ALIGNMENT INDUCED RUNOUT IS NOT
